MOLD PREVENTION IN LISTED CHURCH WITH THE ROTRONIC MONITORING SYSTEM RMS

*The Protestant-reformed church of Mönchaltorf is fighting mold of the genus *Aspergillus glaucus*. The fungus, which decomposes wood, is causing problems, among other things, on the ceiling of the more than 500-year-old building and to its organ. The solution: the RMS Rotronic Monitoring System, which monitors temperature and humidity continuously in order to control the quality of room air and minimize mold growth.*

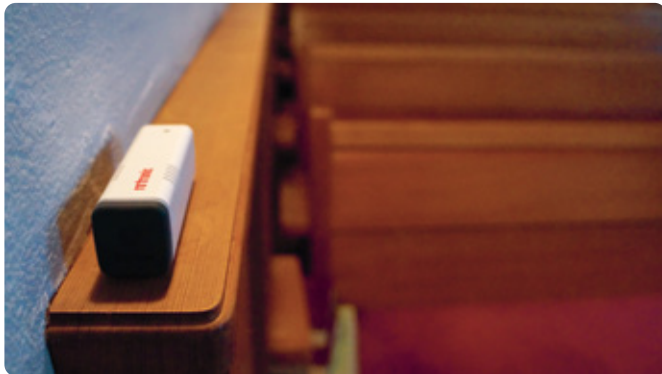
RMS wireless mini data logger records humidity and temperature.

In cooperation with Marcel Jenny, Key Account Manager at Rotronic, a solution involving continuous monitoring of temperature and humidity was implemented to obtain up-to-date data to enable timely adjustments. The online humidity and temperature loggers were placed on the gallery and its ceiling, on the ceiling of the nave as well as at the pulpit in order to record room and ceiling measurements as best possible.

The data can be viewed at any time and from anywhere via the Internet. Should the values rise above pre-defined limits, the system triggers an alarm for the property manager. He can then immediately take measures to regulate the humidity.

- 4 RMS mini loggers to measure temperature and humidity (used on the gallery ceiling, on the gallery, on the ceiling nave and at the pulpit).
- 1 RMS-GW-868 gateway
Interface between the wireless data loggers and server software. It can manage up to 60 data loggers simultaneously and has 5 radio channels for parallel and redundant operation.
- 1 RMS Cloud Software

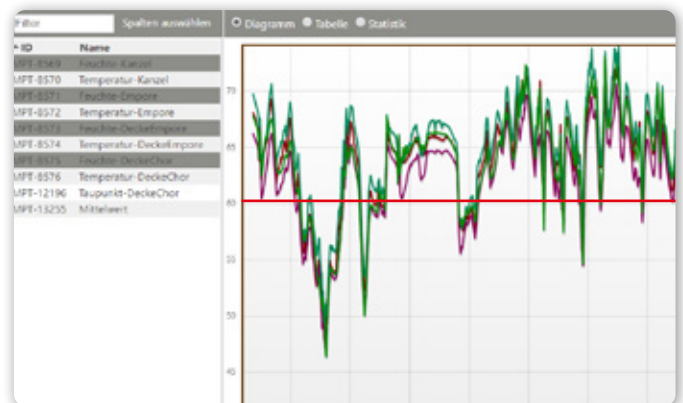
Measurement curves in summer

It soon became clear that the humidity throughout the church rises well above 65% or even up to 75% in the summer. These high values promote the growth of mold. A measure was needed here to protect the valuable ceiling and gallery.

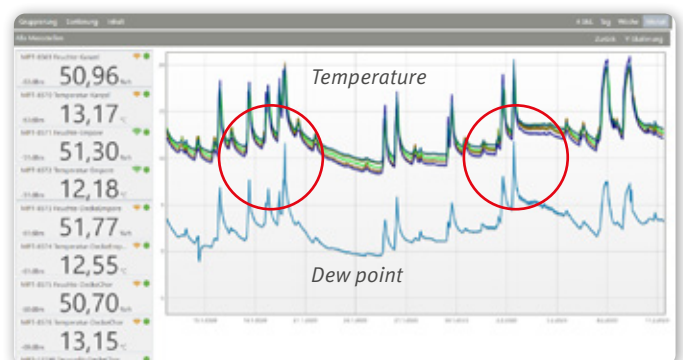
Measurement curves in winter

Based on the pronounced deflections in the temperature curve in the figure above, it is easy to observe how the church is heated before services and other occasions.

Old and thick church walls generally only adapt to room air very slowly. This can be clearly seen in the figure, as the room air changes by only 1.2°C after a weekend (two deflections). The temperature of the church walls thus remains between 10°C and 13°C.

It can also be seen that the dew temperature is exceeded in every heating cycle or comes very close to it (see circles in the figure). In this situation, a local relative humidity of 70% and more can easily arise.

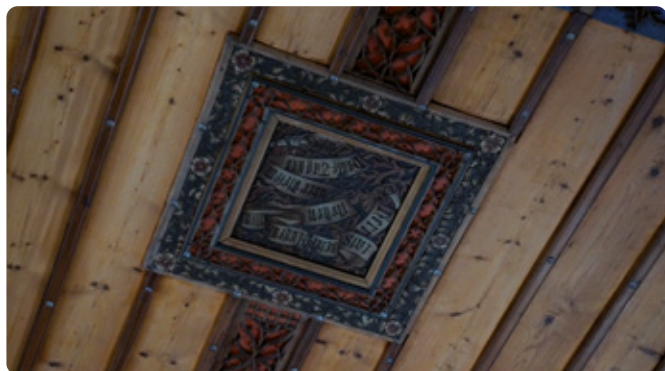
Gallery with organ and late Gothic ceiling carving (monument protection category IV).

for the late Gothic ceiling carvings and paintings, but also for the wooden seating and the gallery including organ. To clarify the origin of the problem, Benedikt Ambühl turned to Rotronic, a company known for its measurement technology, which recommended RMS.
